Sure Check Home Inspection, Inc.
19 Alliance Street
Valley Stream, New York 11580

Property Address:
City State Zip: Mamaroneck, New York 10543

Inspection Date June 3, 2013

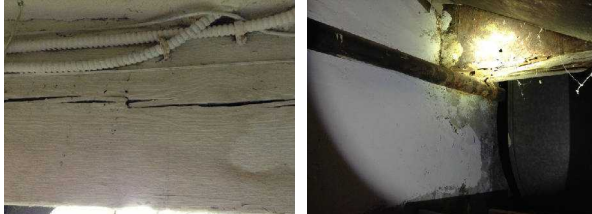
1. Acceptable Structure Type: Wood frame
2. Defective Foundation: Poured, Stone Stone foundation needs pointing. Foundation in back corner of laundry room damaged due to water penetration.
3. Defective Beams: Solid wood Main wood girder checking with extensive termite damage

4. Defective Joists/Trusses: Inaccessible Joists covered by plaster ceiling. Where exposed termite damage noted. Suspect hidden termite damage in basement. Second floor sagging. Problem with joist framing by main stairs. Possible cracked joists.
5. Acceptable Piers/Posts: Steel posts
6. Acceptable Floor/Slab: Poured slab Some cracking noted.
7. Acceptable Stairs/Handrails: Wood stairs with wood handrails

Open entire basement and repair as necessary all basement floor joists. Inspect heating and air conditioning ducts for possible damage and insulate. Replace both main wood girders in basement.

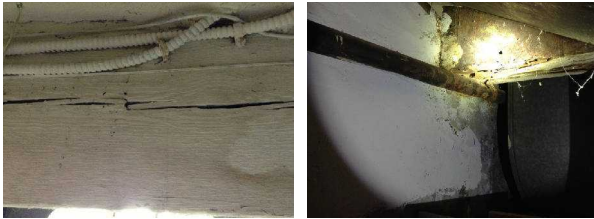
7. Foundation: Poured, Stone Stone foundation needs pointing. Foundation in back corner of laundry room damaged due to water penetration.
8. Beams: Solid wood Main wood girder checking with extensive termite damage

9. Joists/Trusses: Inaccessable Joists covered by plaster ceiling. Where exposed termite damage noted. Suspect hidden termite damage in basement. Second floor sagging. Problem with joist framing by main stairs. Possible cracked joists.
